# 2023 Research Report

# A Study into Fire Alarm Systems with Consideration of People with Sensory Sensitivities

Sonny White

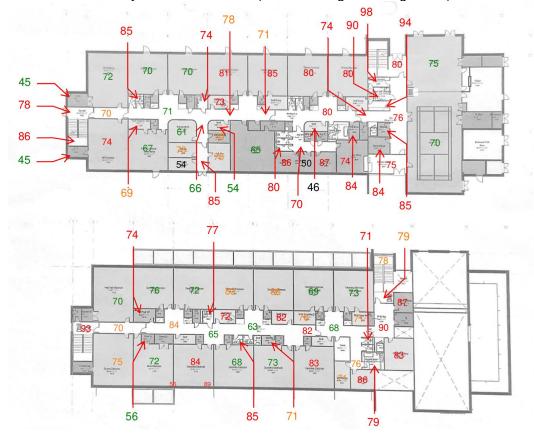
A black number shows: No sounder within the room (Austen academy only)

Notes: This is specific to each room depending on and DB levels can be okay in one room and not in another, this can be because of the objects within the room (soft furnishing absorbing sound) or the location/number of sounders.

- Adjustment of sound level settings in all detectors throughout the building to achieve 65 dB A and no more. Changing rooms and toilets to be set at 60 dB A.
- Removal of sounder VAD bases within stairwells or replacement with VAD-only bases
- Adjustment of sounder VAD bases throughout the building to a lower volume setting via the dip switches and dial
- Replacement of XP95 multi sensors with either Discovery multi sensors on day night mode (with the smoke element off during the day) or with a heat detector.
- Removal of smoke detectors and sounder VAD bases from the toilets. Risk assess in relation to students with hearing loss and (if appropriate) install VAD only bases.

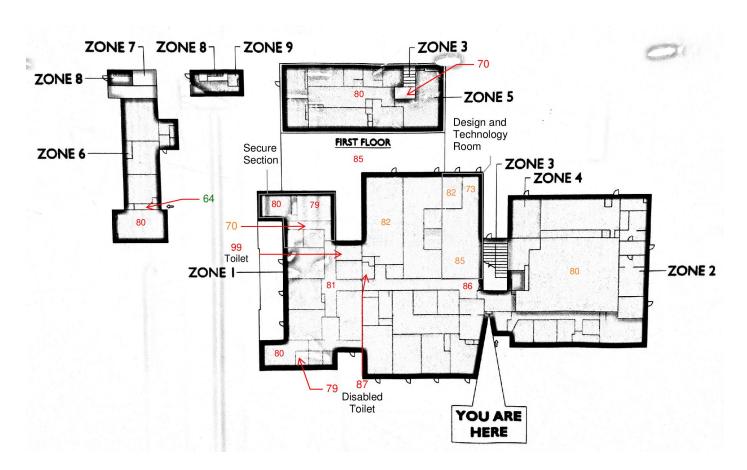
A Green number shows: Appropriate for the location within the building.

Notes: This is specific to each room depending on and DB levels can be okay in one room and not in another, this can be because of the objects within the room (soft furnishing absorbing sound) or the location/number of sounders. Due to the significant amount of sounders within the building the DB level does not always represent the sound level accurately, the sound level reading could be significantly lower than the standards require but sound to the human ear as if it was within the standards, as it is clearly audible.
